## HLH ROTOR BLADE MANUFACTURING TECHNOLOGY DEVELOPMENT REPORT

Boeing Vertol Company  
P. O. Box 16858  
Philadelphia, Penn. 19142

September 1977

Final Report

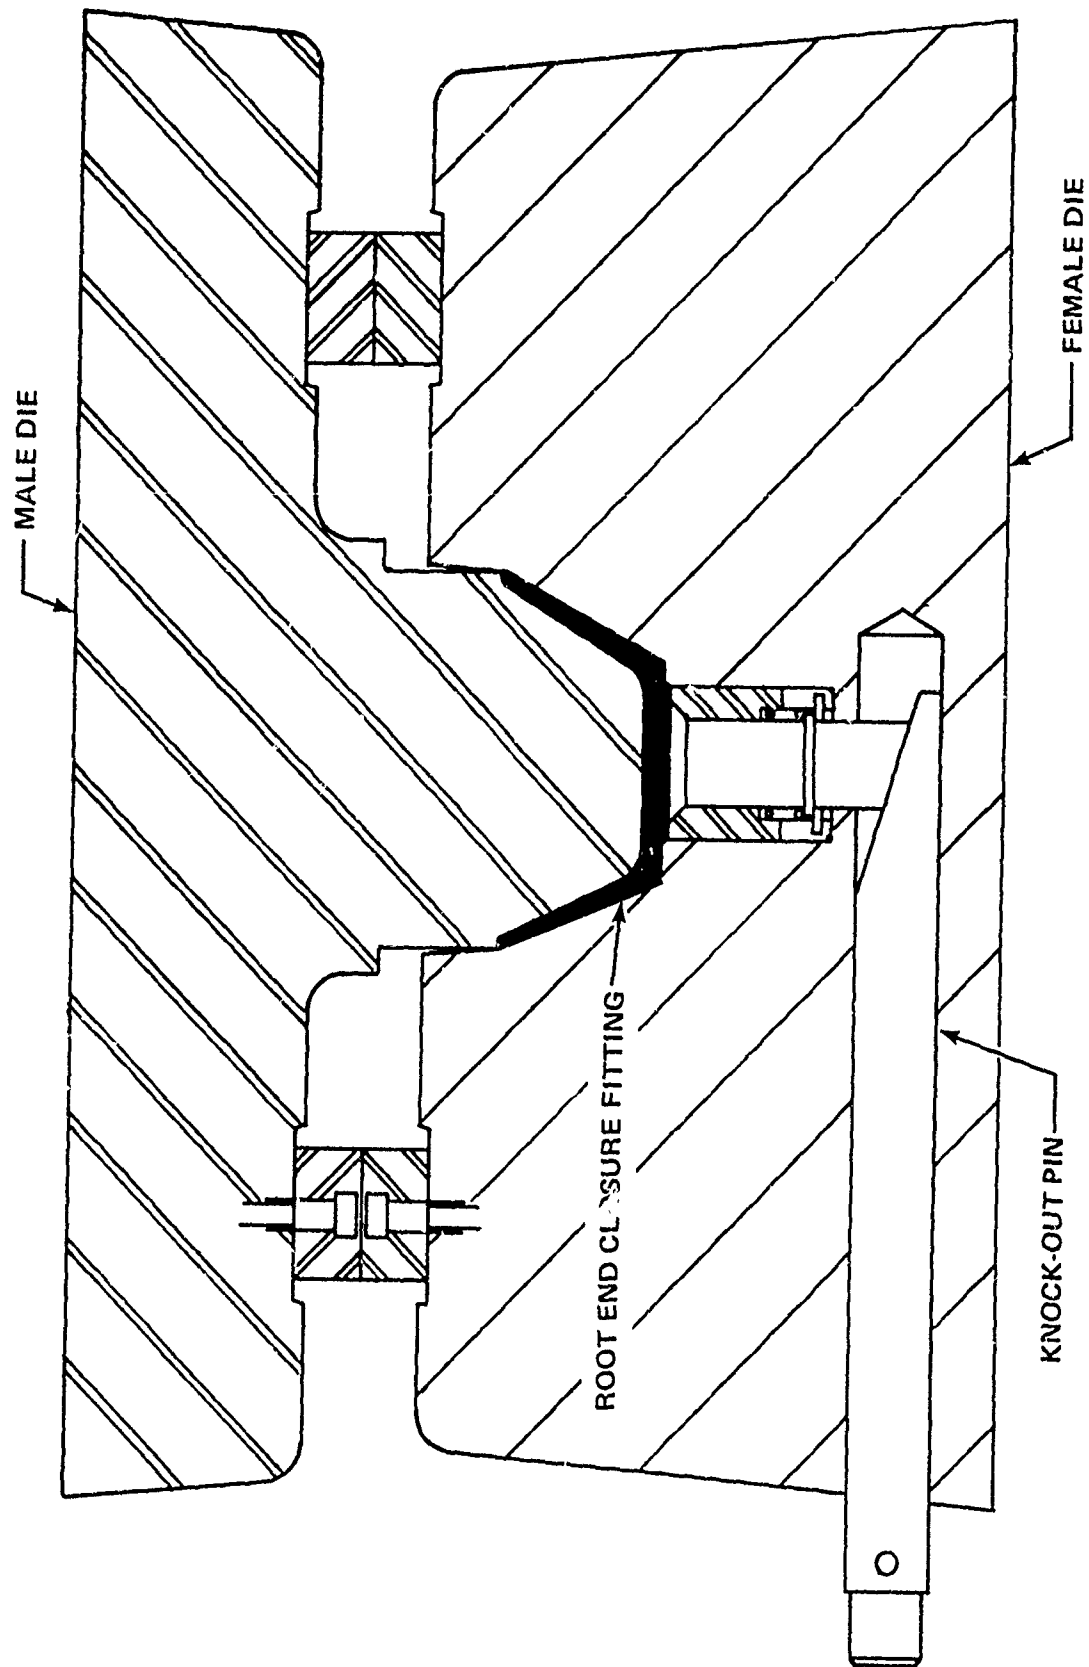
Figure 47. Kirksite Die, MD SK301-111204-1, for Chopped Fiber Compression Molded Part Fabrication

A kirksite die (MDSK301-11204, Figure 47) was made which incorporated all the features found to be lacking in the original aluminum tool. Some of these things were chrome plating of all mold surfaces, knockout pins and improved methods of handling.

The aluminum mold produced the parts for the test piece, but the tool itself was not satisfactory. Since the tool was soft, it was subject to damage (tool marks, etc.) in loading and unloading; tapped holes for inserts were easily stripped; and because of the high cure pressure, the mold had deflection problems.

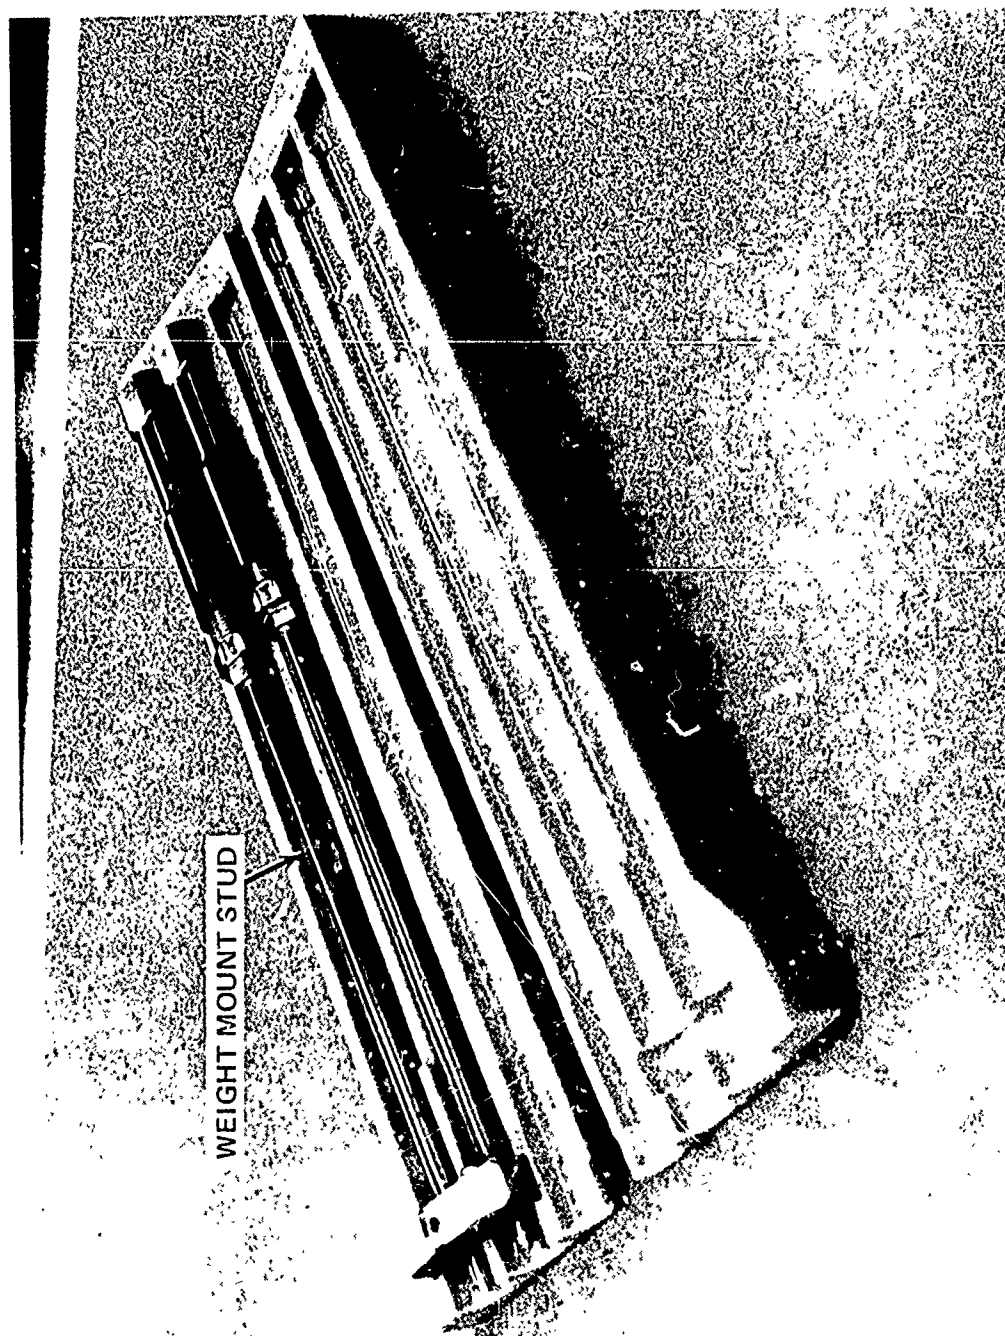
Figure 48. Forward Weight Fitting — Showing Upper and Lower Molded Halves, Internal Tubes and Blocks, and Studs Used for Mounting Balancing Weights

The tip balance weight fittings, 301-11184-1 and 301-11186-1, are made from the same chopped fiber material (SP 1157) as the root end fittings. They are, however, more complex in that they have metal tubes and plates built into them for retaining the weights. Because of the design, each of the fittings had to be molded in two halves and then bonded together with the tubes in a separate operation. Each half fitting then required a separate mold. See Figures 48, 49, and 50.

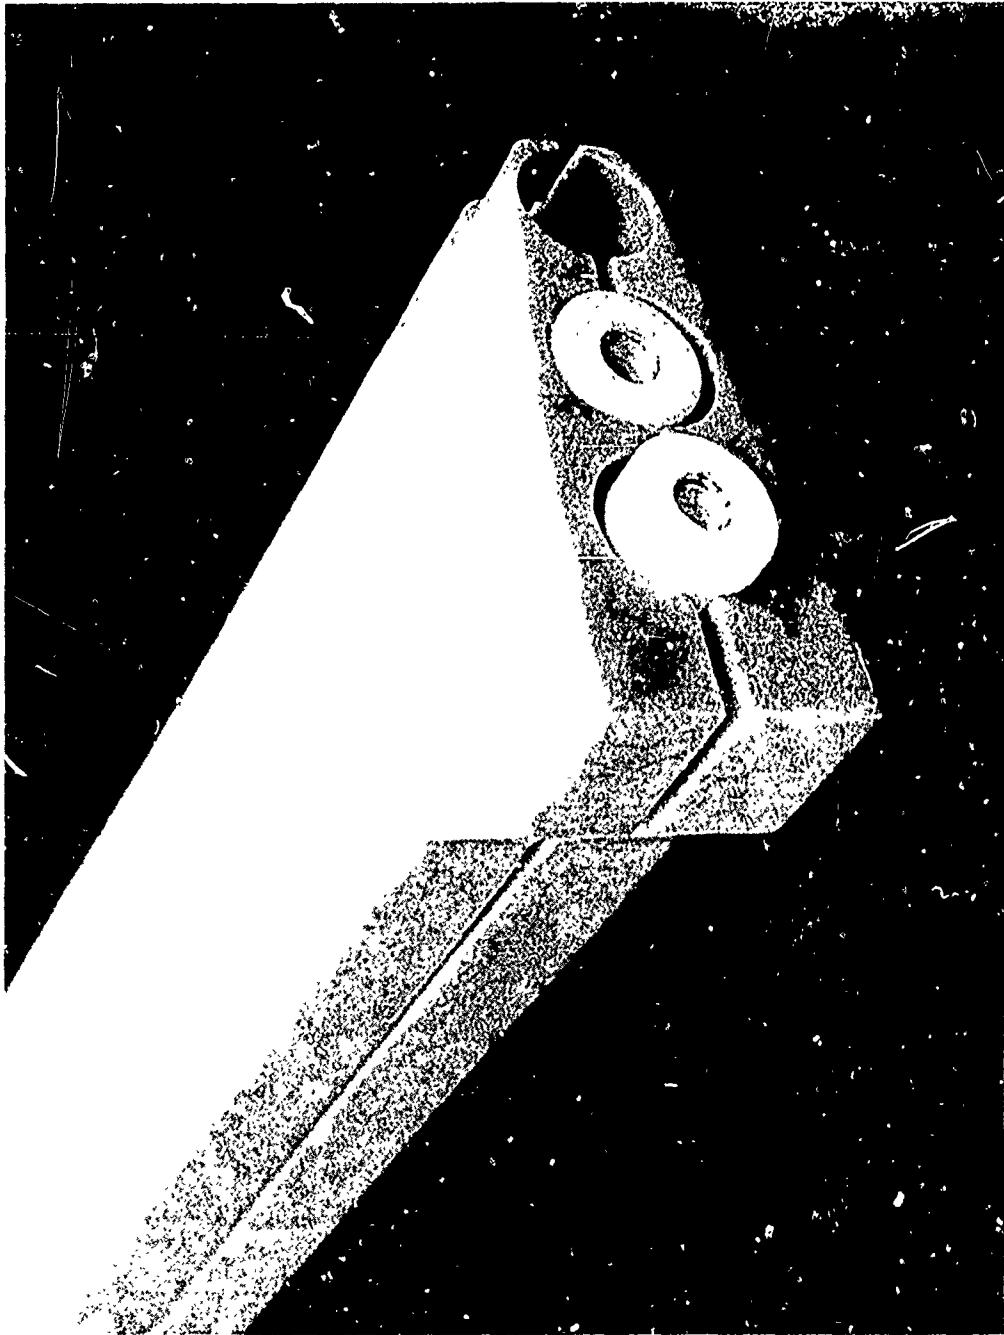
*Figure 49. Forward Weight Fitting Subassembly — In Preparation for Bond Operation*

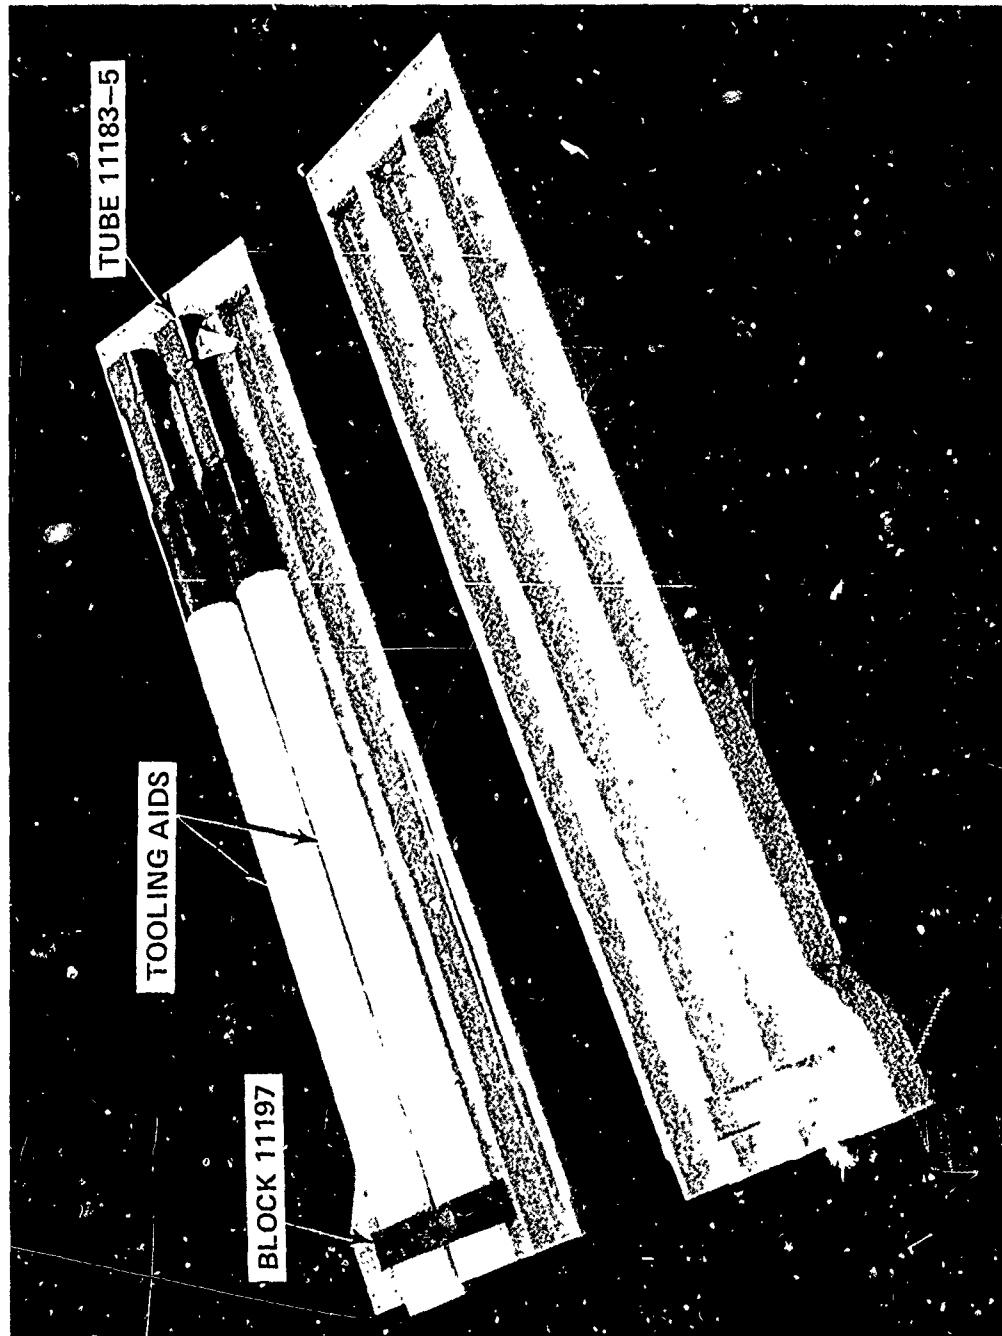
Figure 50. Forward Weight Fitting in Preparation for Bonding

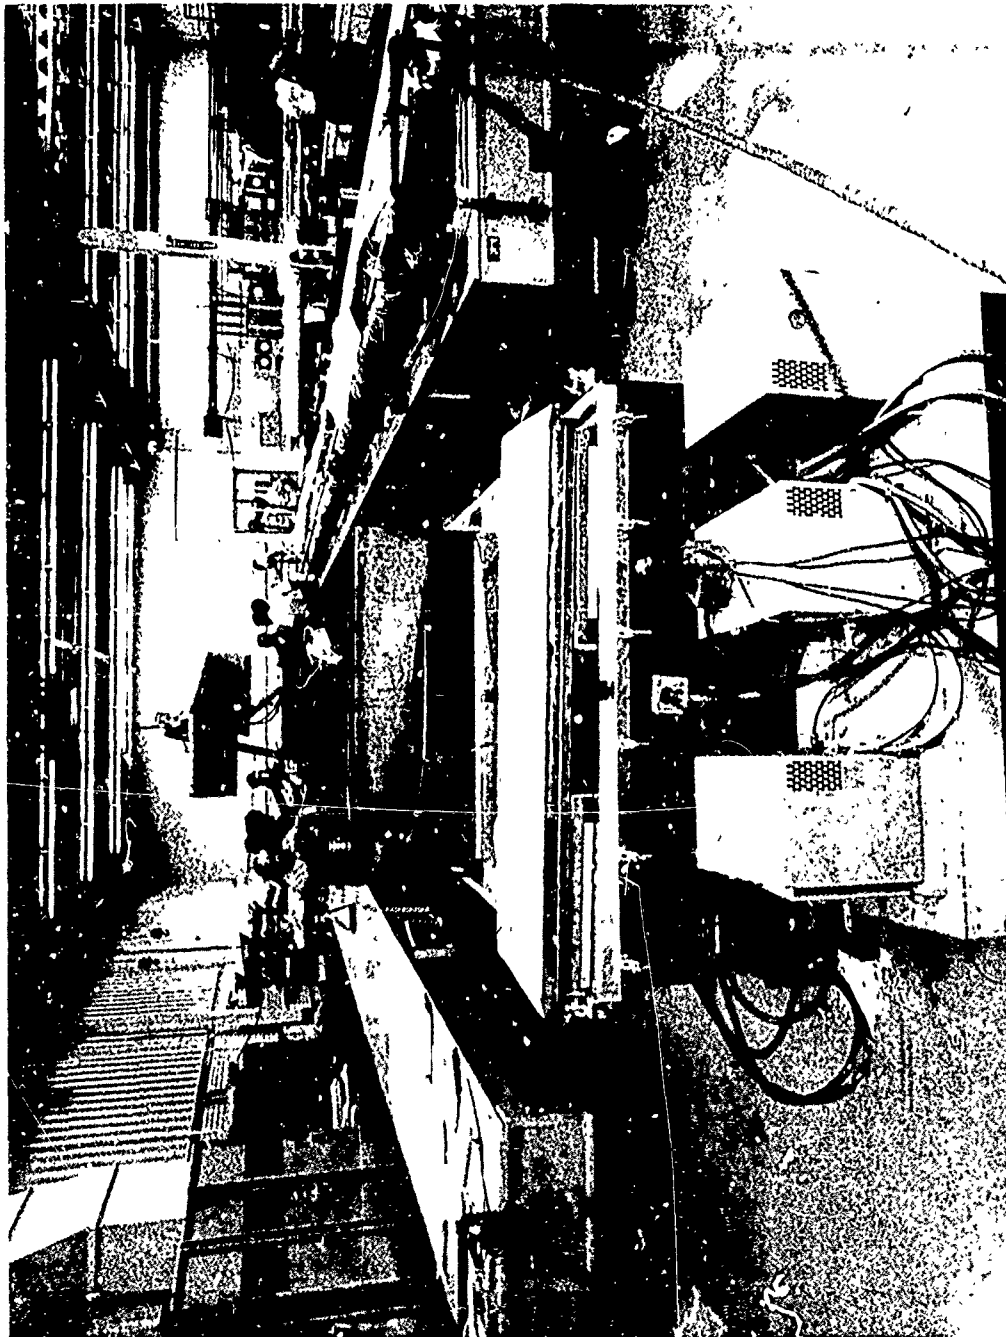
*Figure 51. Closing Main Bond Tool for Bonding of First Blade*

Most comments made for the spar BAJ are also applicable to the final BAJ (fixture which bonds the aft fairing to the spar) with the exception that it is much wider and heavier. See Figures 51 and 52. The pressure required for this operation is derived from oversize machining of the honeycomb core and machining the fixture to the proper OML of the blade. Because of this, as in the spar BAJ, the castings were machined using the MDI method, which closely controls the contour, twist and other parameters.

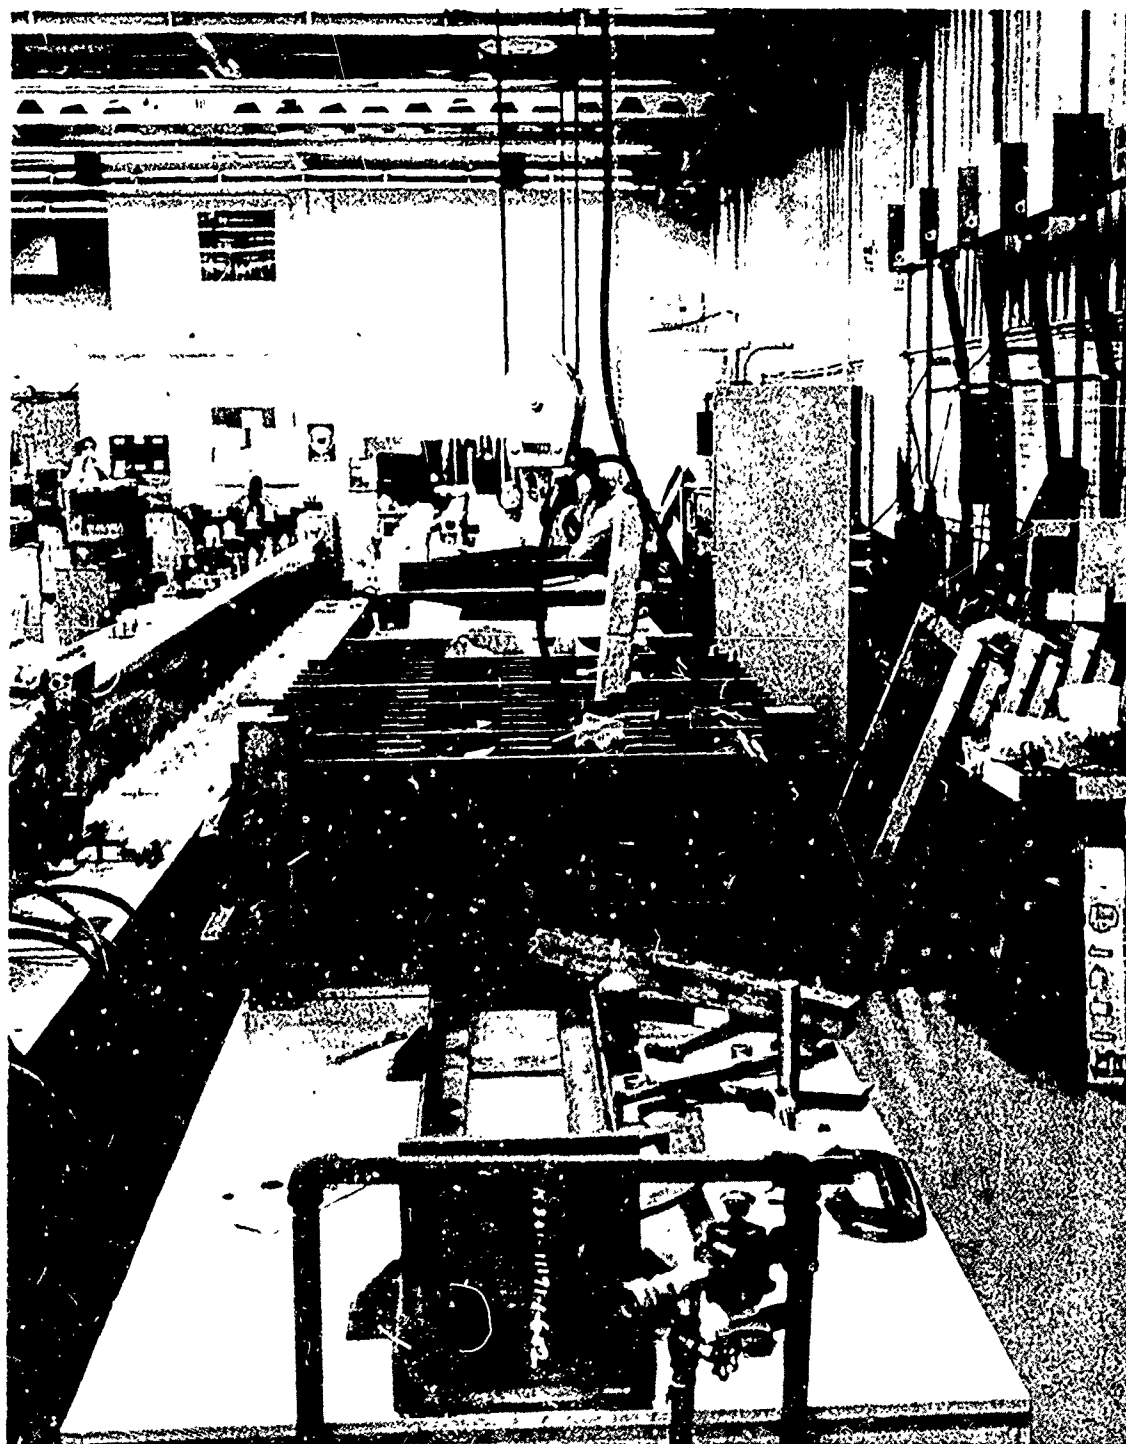
*Figure 52. Simulation of Prefit Operation Prior to Actual Use of Final Bonding Fixture*

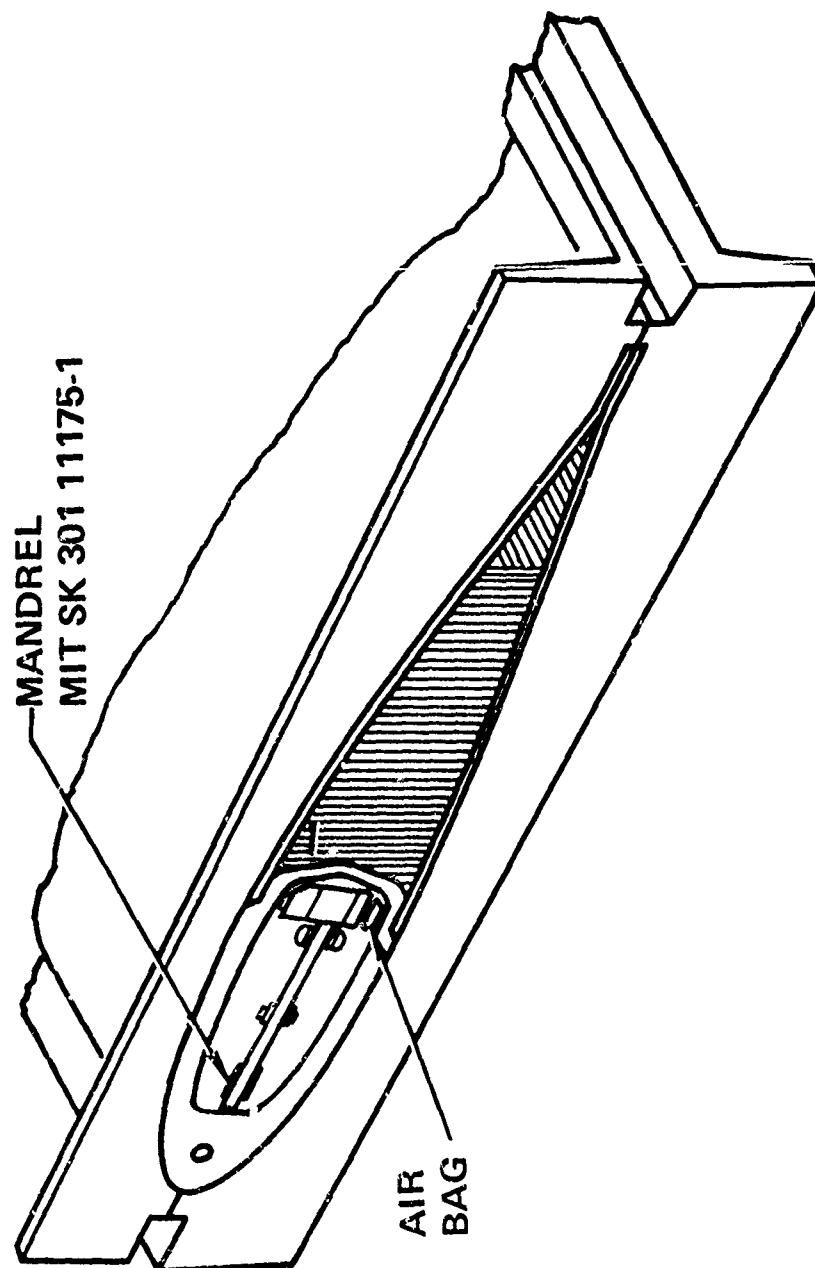
Figure 53. Special Mandrel Used to Support Spar Heel During Final Blade Bonding Operation

During the bonding of fairing to blade, a special mandrel (MIT SK301-11175, Figure 53) is inserted into the spar. This mandrel applies an internal pressure of 80 psi at the spar heel to ensure a good bond of the skin fairing to the spar. In addition, both ends of the spar are capped, and the entire spar is pressurized from 8 to 10 psi to prevent any delamination of the previously cured spar.

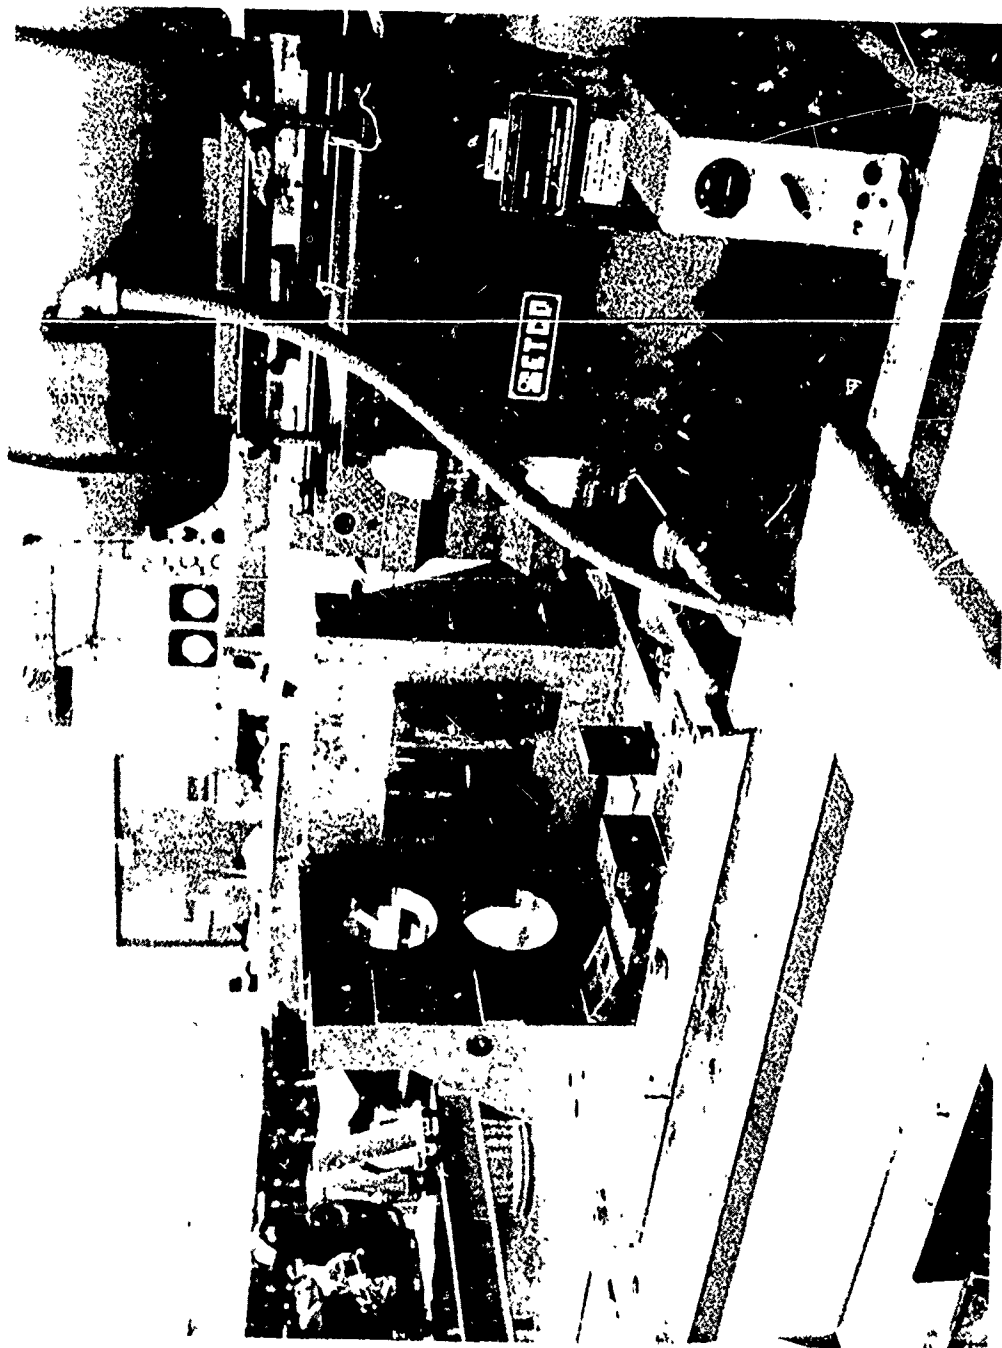
Figure 54. Root End Boring Fixture BOF SK301-11171-1

Boring fixture BOF SK301-11171-1, Figure 54, was specifically designed and built to properly locate the blade using a special outboard stand at Station 414 and locating pads in the root end area. The machine was designed to use a twin-spindle boring head to maintain hole spacing; special boring bars and cutters were supplied to complete the operation.

Design of the boring fixture also provided for installing the lag damper arm, sleeves and washers that are assembled and bonded into the blade.

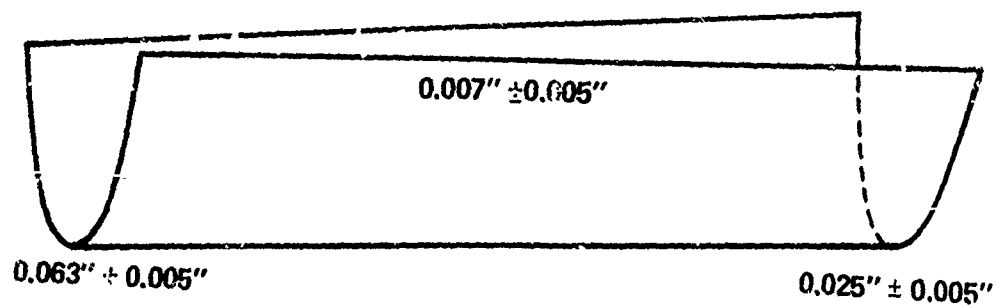
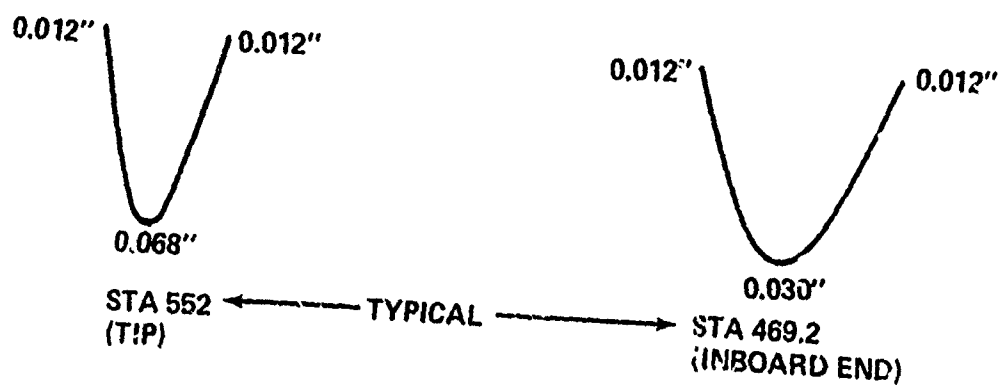
Figure 55. Typical Nickel Erosion Cap

Trimming of electroformed nickel erosion caps is necessary due to the nature of electroforming itself. Electroformed edges are typically irregular, show thickness variations, and include nodulation or bead-like growths of extensive proportions (Figure 60). As an aid in removing the crust-like nodule formations, the electroform mandrel is masked in such a way as to produce an easily-fractured line from which the noduled edges are broken off. This leaves a fractured edge (Figure 61) which must be trimmed to dimensional size and dressed to the required surface finish requirements. The fracture line (Figure 62) location is determined by the masking tape position and generally is  $\frac{1}{4}$  in. to  $\frac{1}{2}$  in. outside (larger than) the net part dimensions to allow for trimming/finishing that satisfies engineering and manufacturing considerations.

Rough trimming is done using hand routers (air driven) with  $\frac{1}{4}$ -in. diameter high-speed straight-fluted bits. Finishing is performed with an orbital hand sander used with 240 grit aluminum oxide cloth discs to remove router tool marks and burrs (Figure 63). This is followed with crocus cloth discs

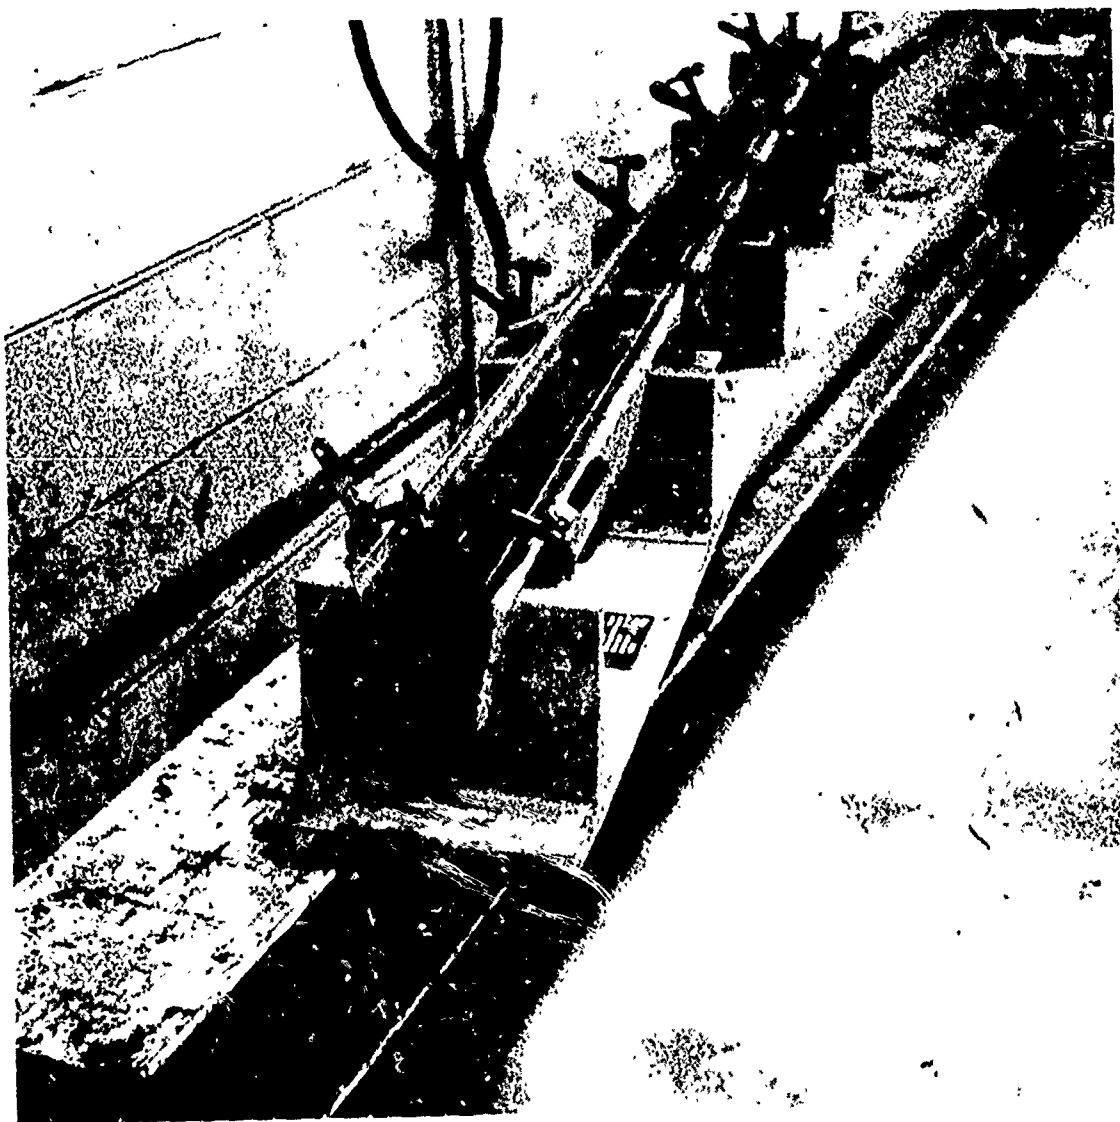
*Figure 56. Nickel (Electroform) Cap in Trim Fixture*

The desired plating requirements were achieved after a plating mandrel (SK301-11189, Figures 56, 57, and 58) was made. Development was conducted by varying the tooling mandrel/plating anode relationship in the electroform process, using existing facilities at Boeing Vertol Company (Figure 59).

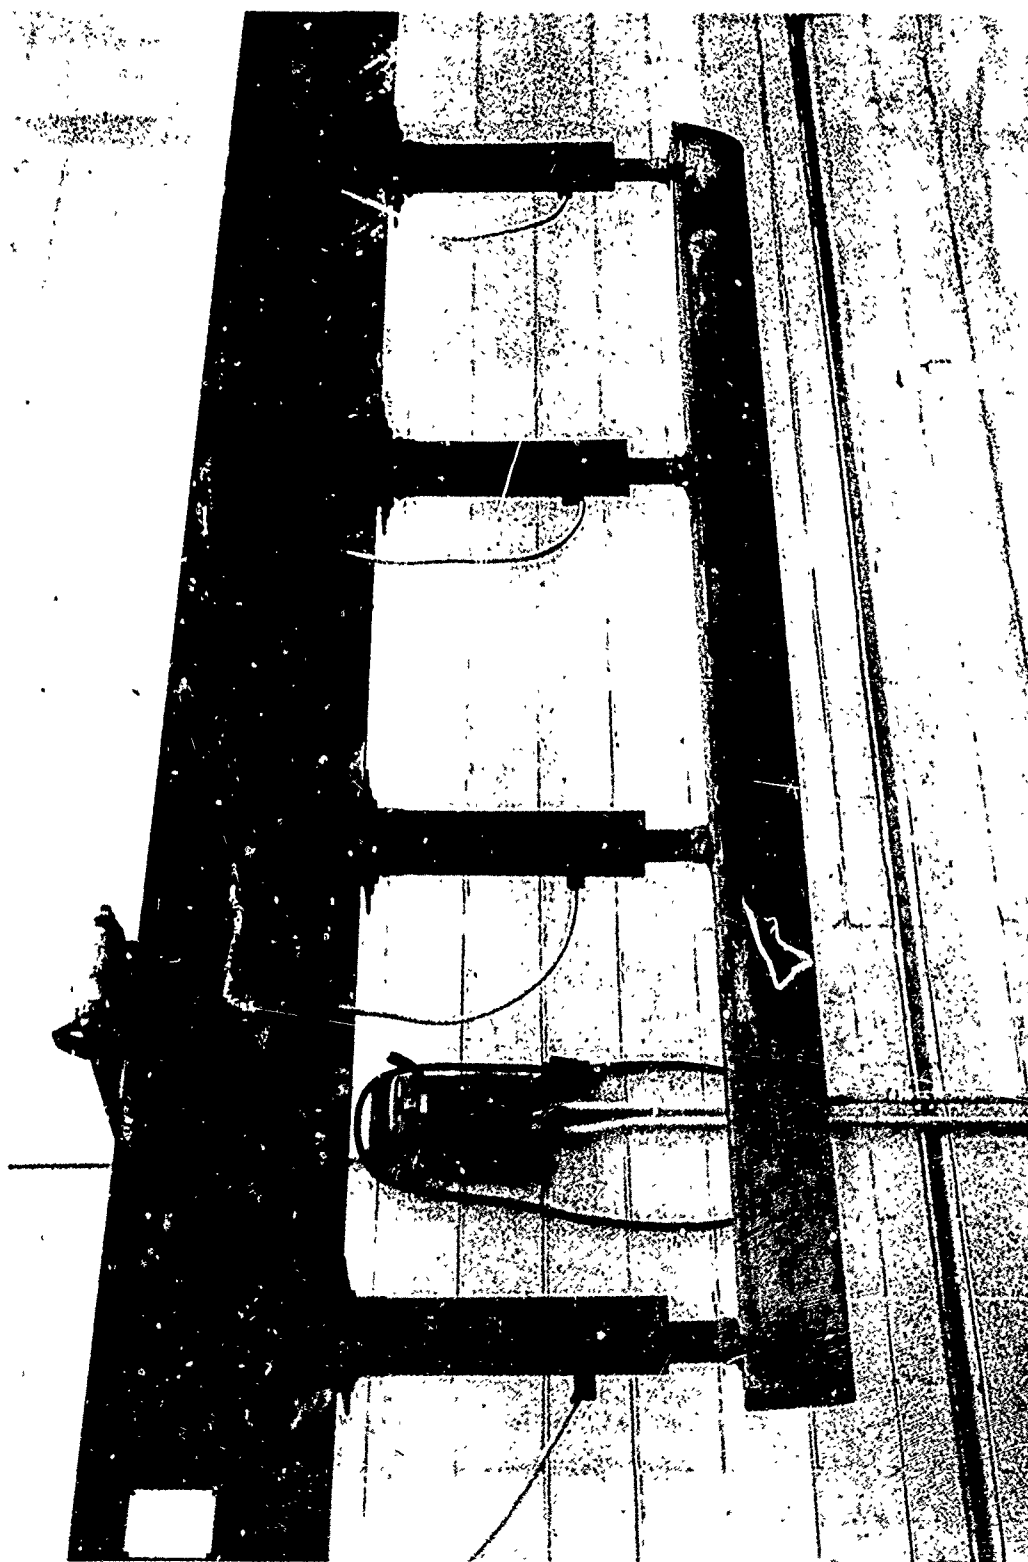
*Figure 57. Erosion Cap Plating Mandrel Mounted and Ready for Use*

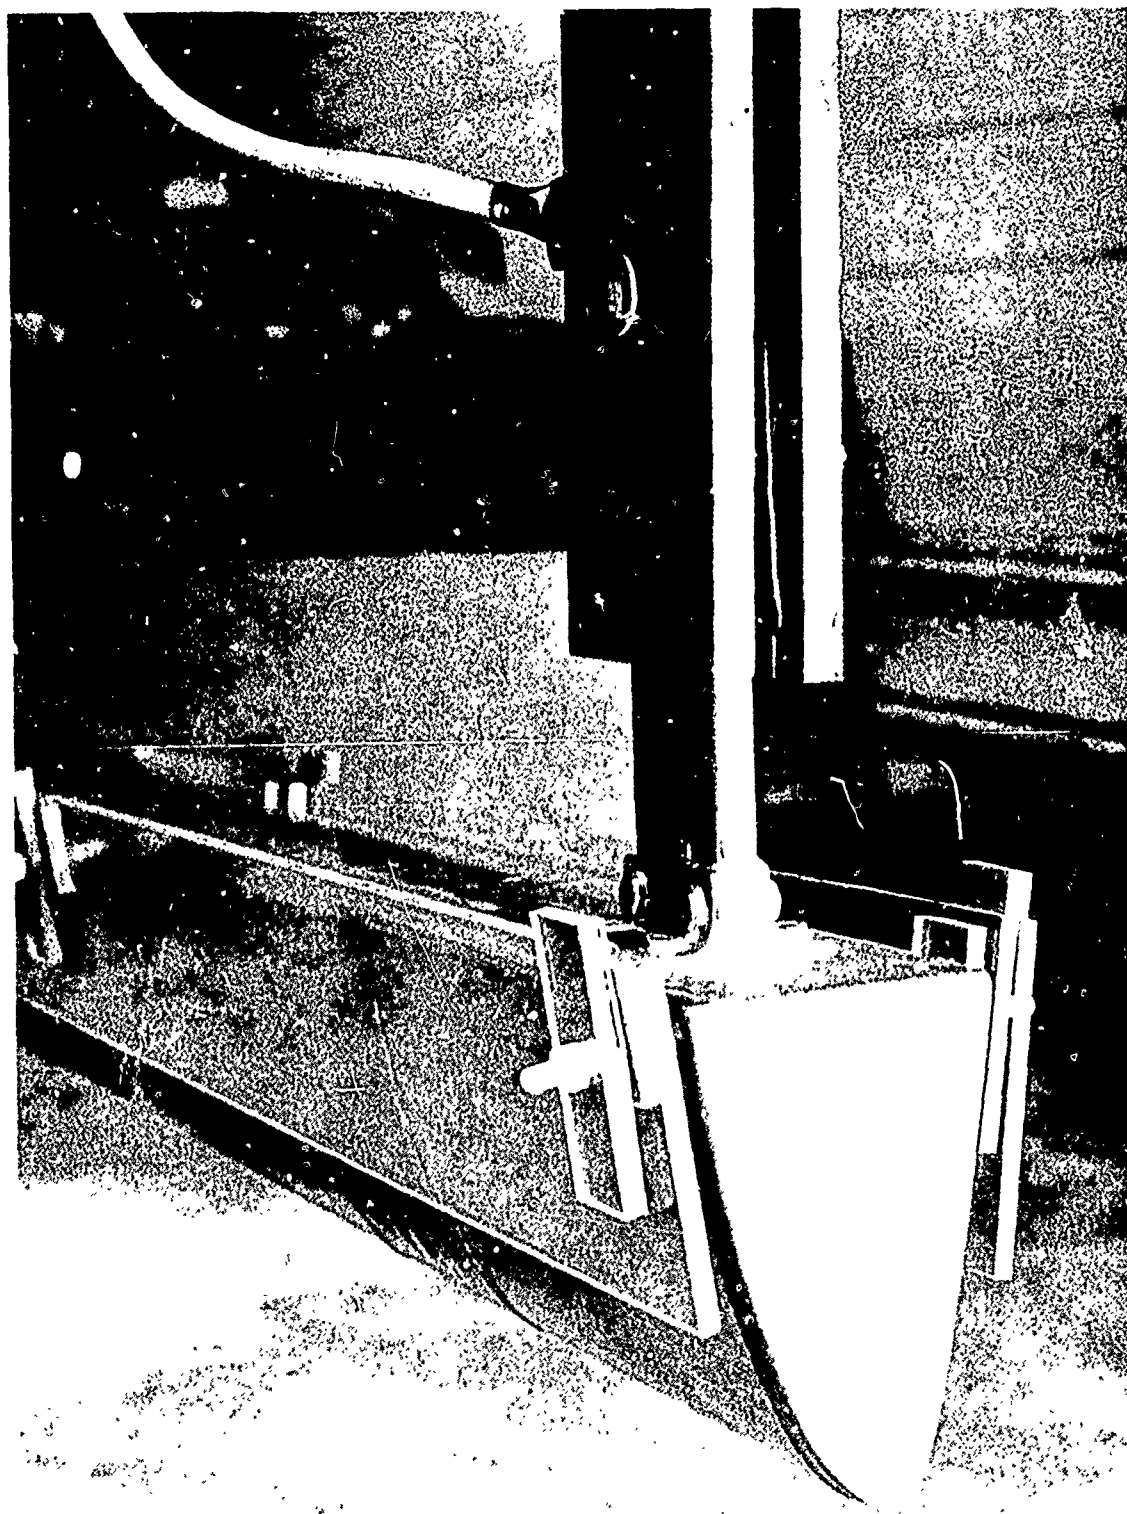
*Figure 58. Details of Erosion Cap Plating Mandrel*

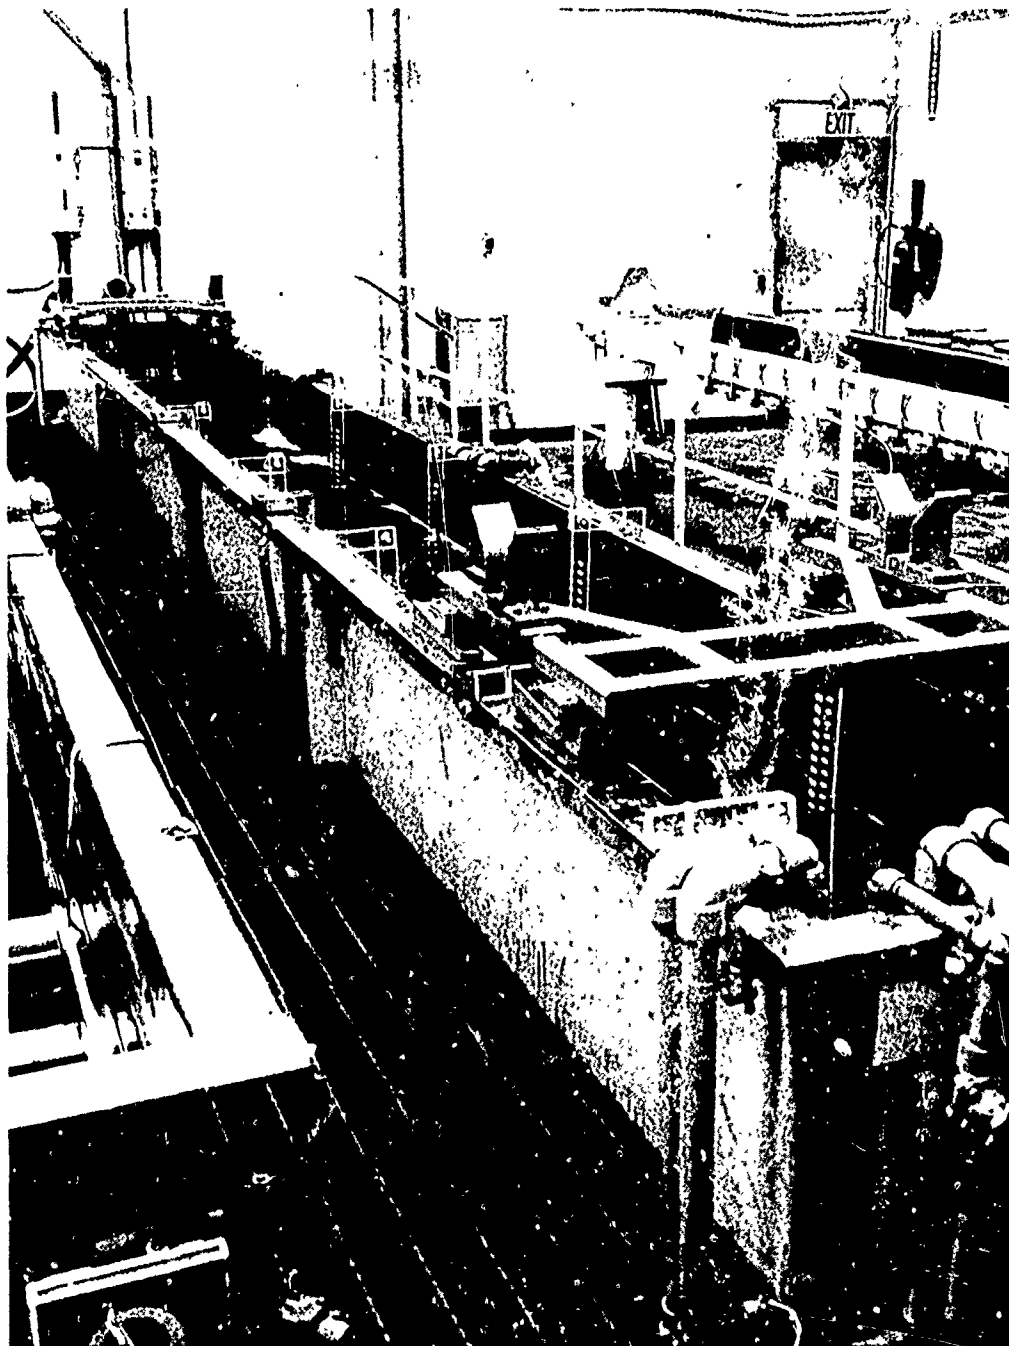
*Figure 59. Plating Facility for Nickel Electroforming Erosion Cap*

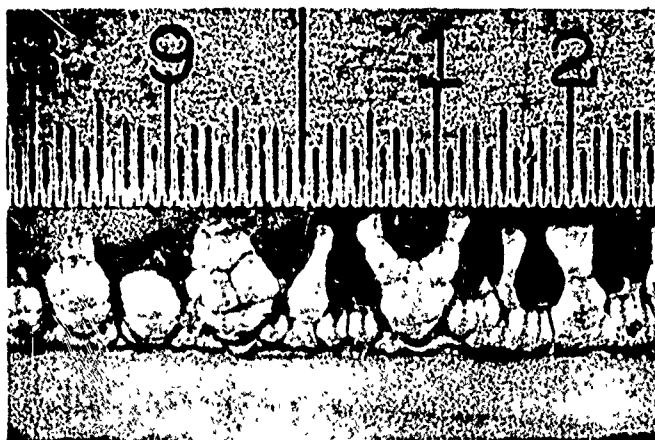
*Figure 60. Edge Nodulation on Electroformed Part*

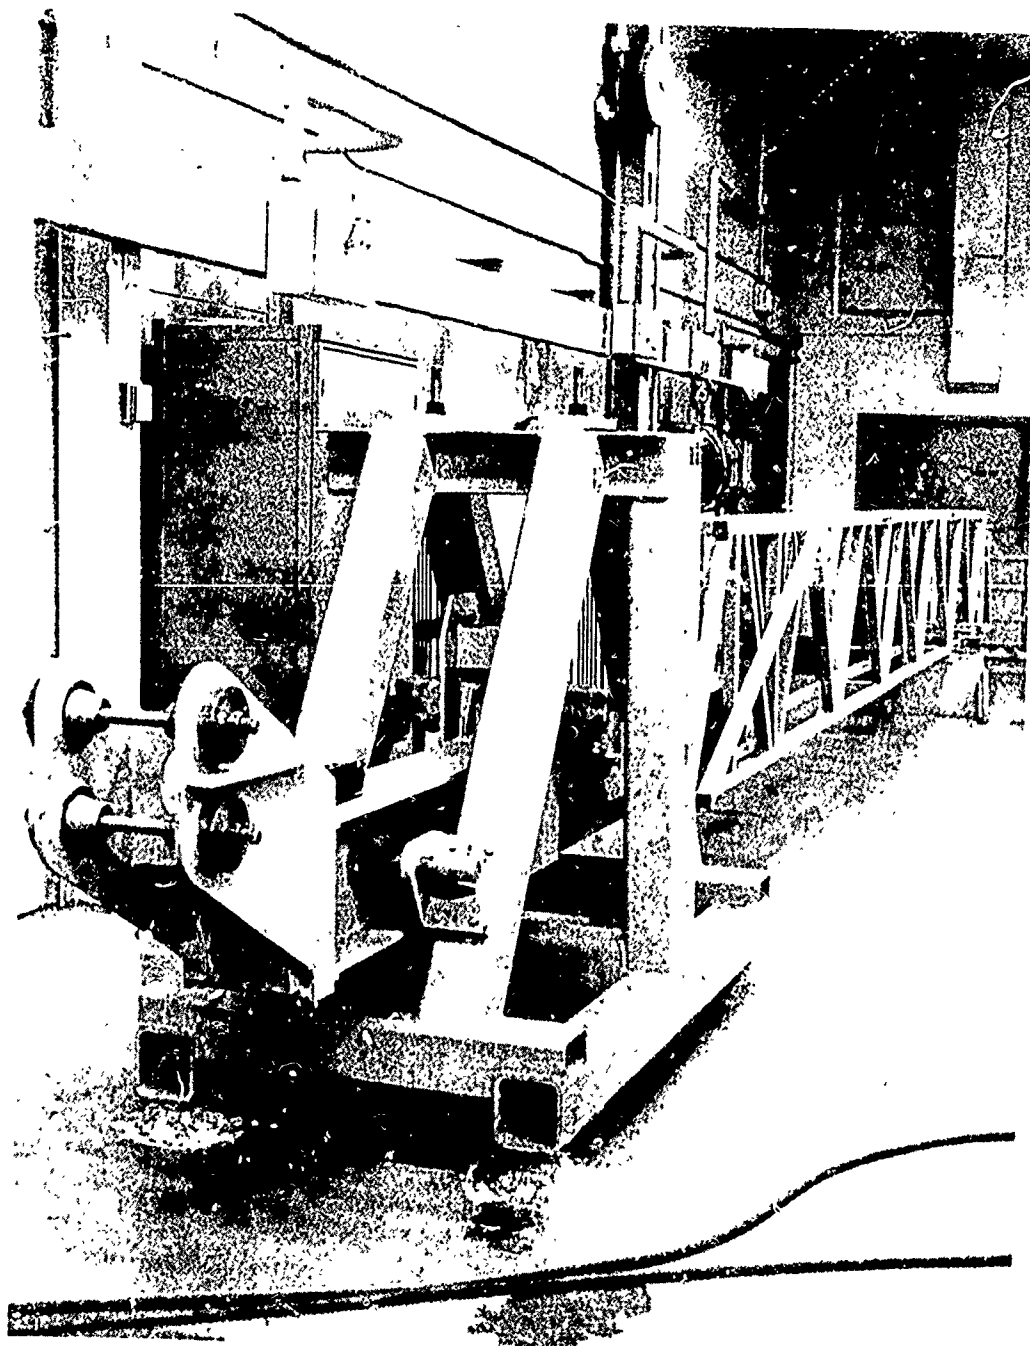
*Figure 64. Teeter Balance Fixture*

All existing teeter stands for the CH-46 and CH-47 models employ a shaft at Station 0.0 going through the balance head and pivoting in bearings. The arc through which the shaft rotates is very small, and only a small section of the bearing is used. Friction, dirt, and other factors affect rotation of the shaft, resulting in poor balance. To overcome this condition, bearings were not used and the balance head was suspended by straps. Because of their availability, four tension/torsion straps used in the Chinook CH-47 aircraft were adopted for this purpose. This method worked very

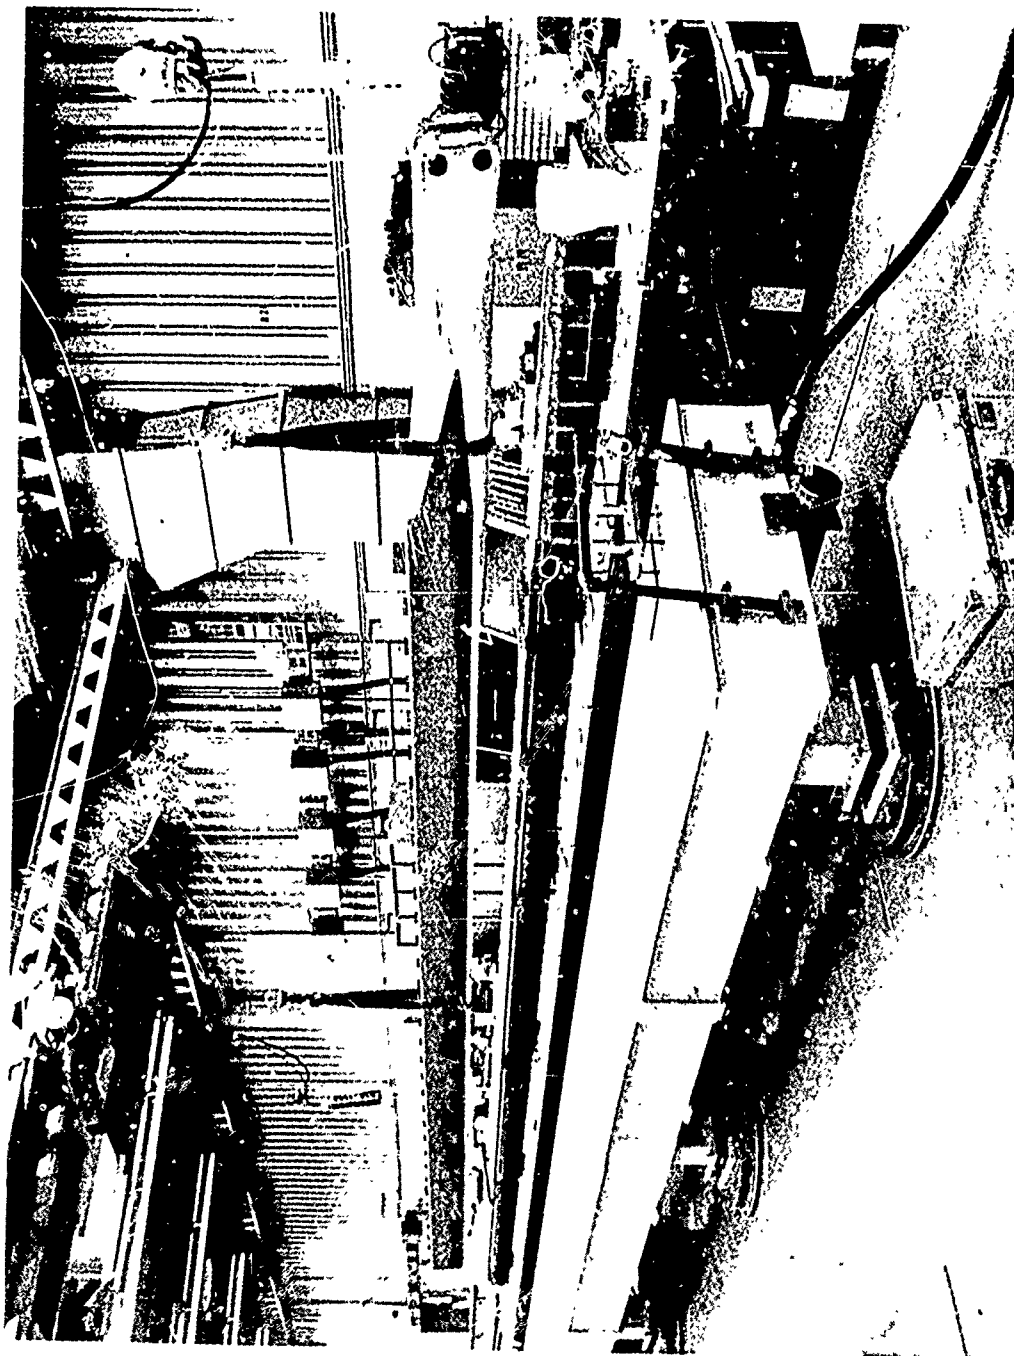
*Figure 66. Unloading Spar No. 1 from Cure Tool*

The method chosen was to make two tables each with ten 28-inch diameter air cushions on the bottom (PME SK301-11171-1, Figure 66) and with an "Air Off" height to match the restraining base. With this system, the complete fixtures could be moved from one area to the other with minimum effort. Note that each of the BAJs had clearances (slots) milled into them to accept 16-inch diameter air cushions to permit moving the tools from table to restraining base or vice versa.
